Roofing & Guttering Services

Drone Survey Report

Property	Phoenix Lodge Mansions Brook Green London W6 7BG
Date	10 August 2023
Client	Katie Steward
Purpose	Client requested a roof report
Prepared By	Steve Scannell 07738 359841

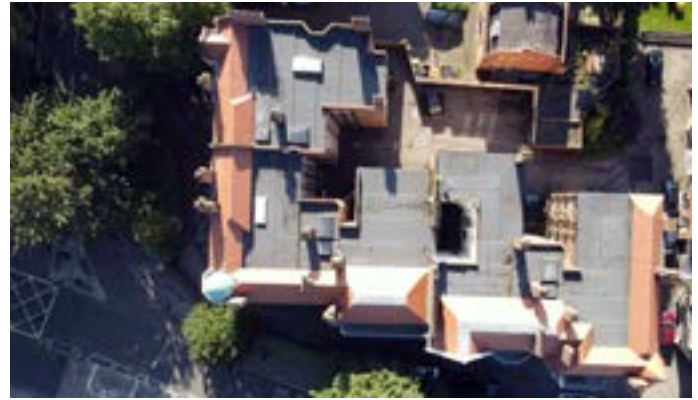
This roof has a pitched roof with guttering. There is also a flat roof present and a large section of Flat Roof.

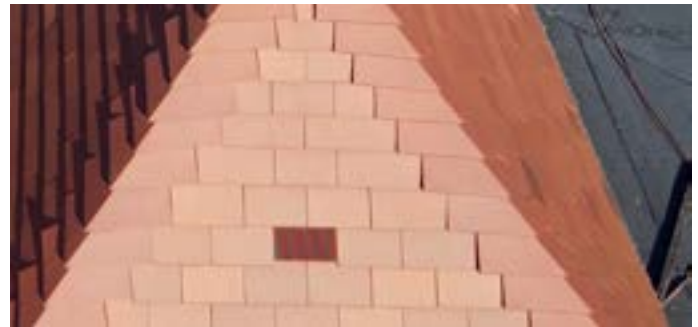
This is an overlapping tiled roof. The tiles that have been used are plain tiles. The roof looks fairly new and the tiles are all in an excellent condition through out, with none damaged, slipped or missing.

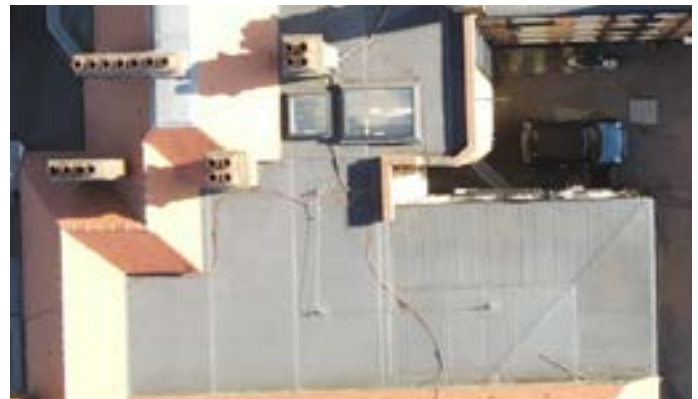
The flat roof has been constructed with an overlapping felt system which appears to be in a good condition. The overlaps are in good condition with no sign of coming away. There is no staining or vegetation on the roof.

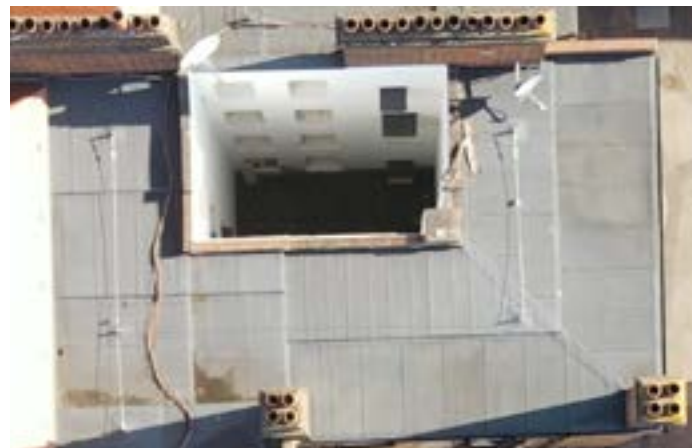
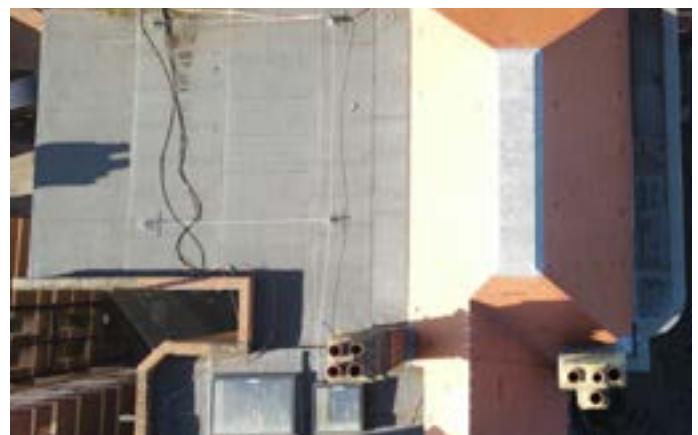
The felt from the flat roof has been dressed up onto the base of the parapet walls and the associated roof lights. This appears to be in good condition with no sign of it deteriorating or coming away.

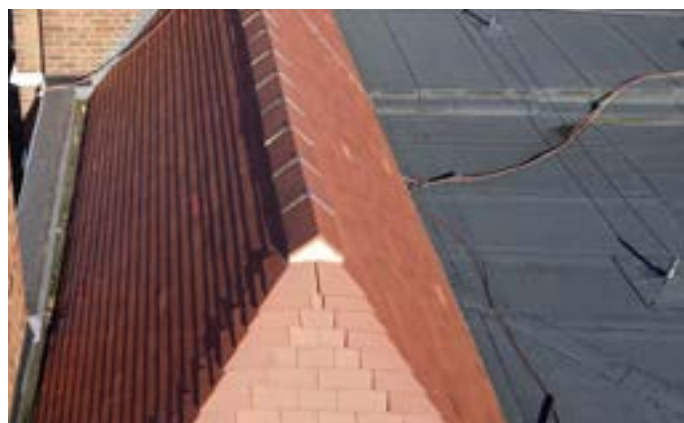
There is a metal ridge capping system. This appears to have been fitted fairly recently and is in an excellent condition.

There is also a section of roof with a concrete / clay ridge system in place which looks fairly new and is in an excellent condition

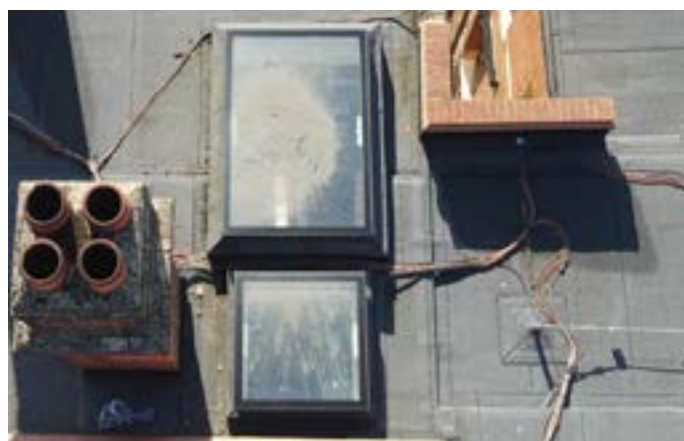
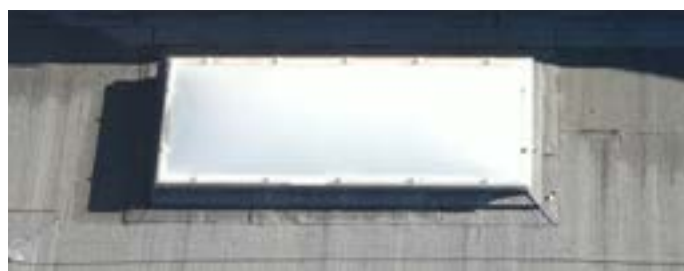
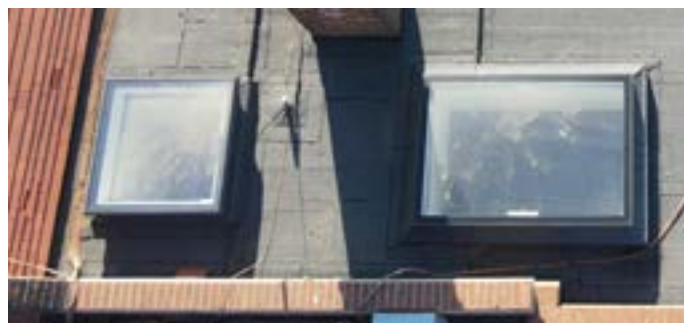
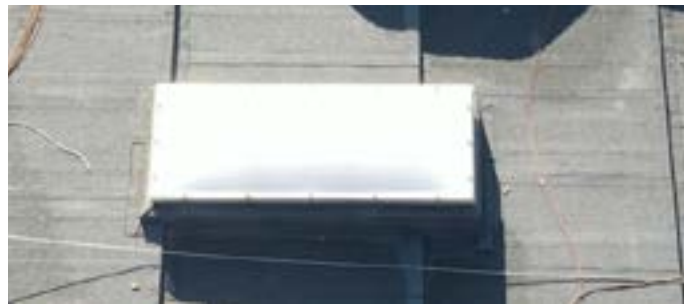
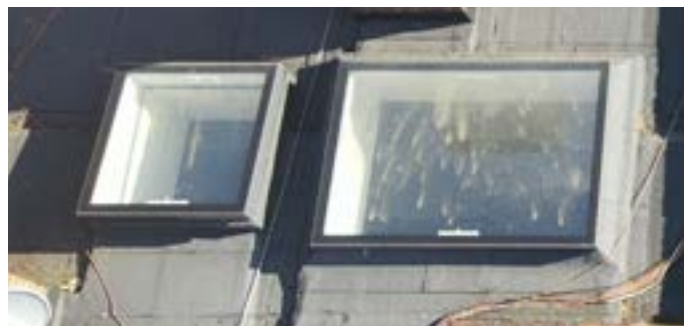
There are a total of 8 roof lights on this block. Two are constructed from a heavy opaque plastic covering and 6 Velux style which are clear and constructed with glass. The felt from the flat roof has been dressed up over the upstands of these lights to prevent water ingress and looks sound.

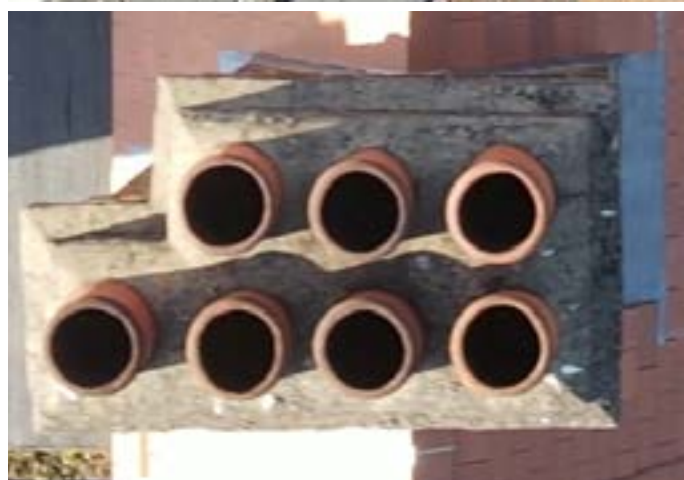
There are 23 chimneys in total on this block. The chimney stacks all appear to be in good condition. They are well rendered and the lead flashing appears to be fairly new, well fitted and watertight. Where there are chimney stacks evident on the flatroof they have felt from the flat roof dressed up onto the bottom of the stacks to provide protection of from water ingress, this all appears in good condition.

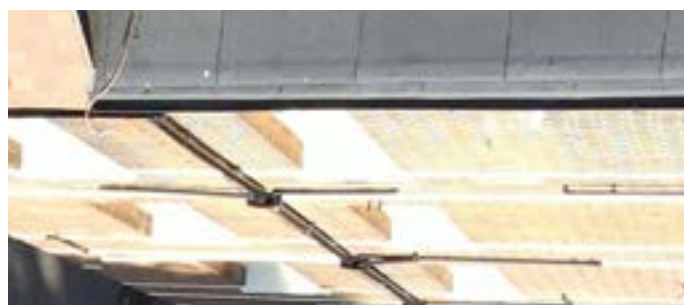
The guttering is clear and the water flow is not impeded by any vegetation or debris

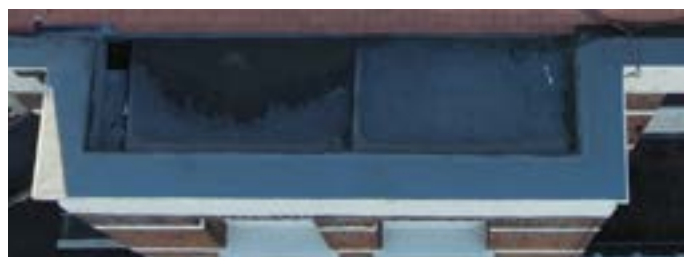
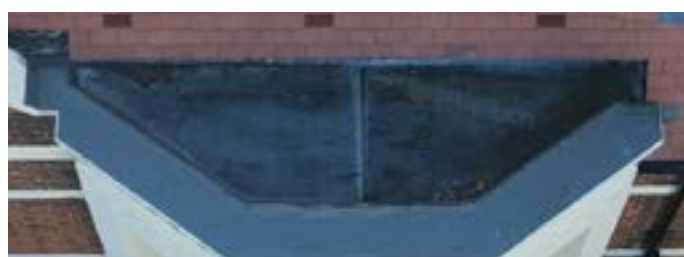
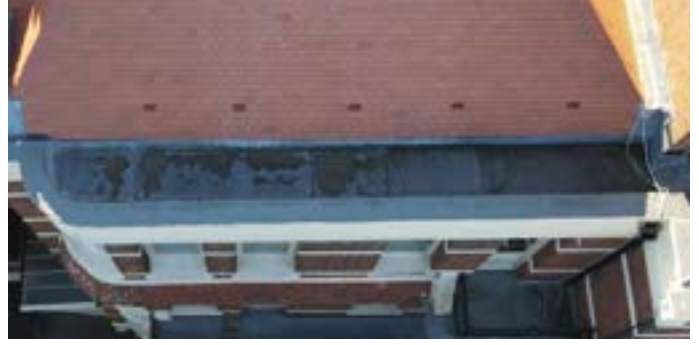
The three bays present on this block have a sloped metal covering to allow rain water to flow through the outlet and into the adjoining guttering. All three are well constructed and are clear of vegetation and debris allowing the free flow of water

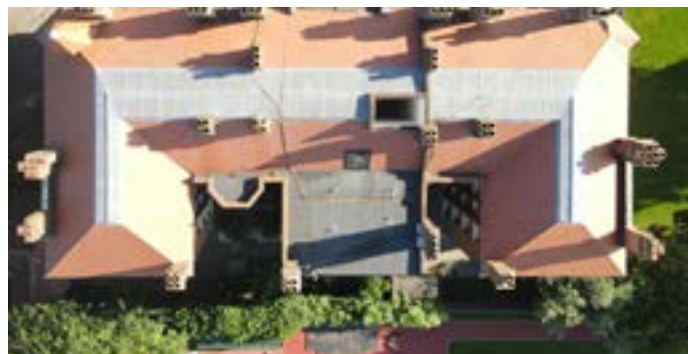
This roof has a pitched roof with guttering. There is also a flat roof present and a very small section of Flat Roof.

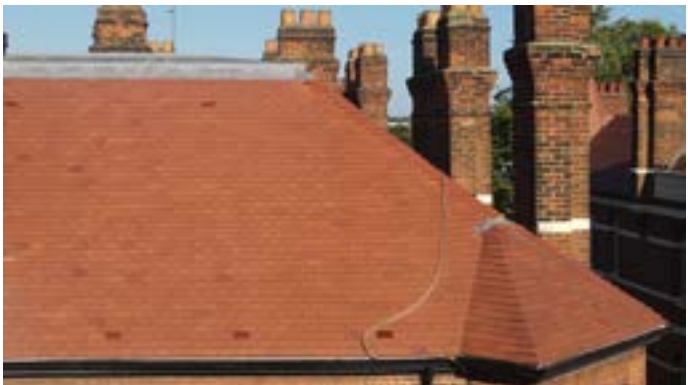
This is an overlapping tiled roof. The tiles that have been used are plain tiles. The roof looks fairly new and the tiles are all in an excellent condition throughout, with none damaged, slipped or missing.

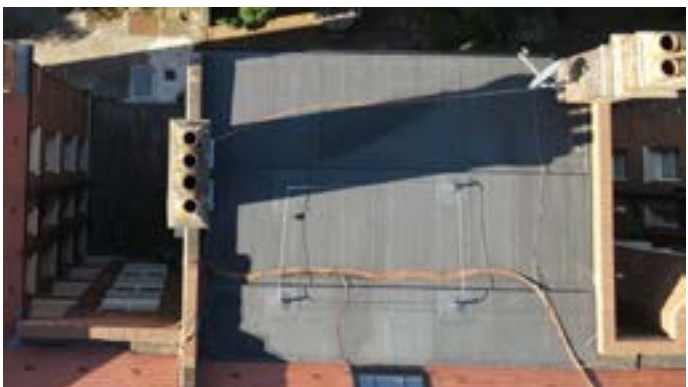
The flat roof has been constructed with an overlapping felt system which appears to be in a good condition. The overlaps are in good condition with no sign of coming away. There is no staining or vegetation on the roof.

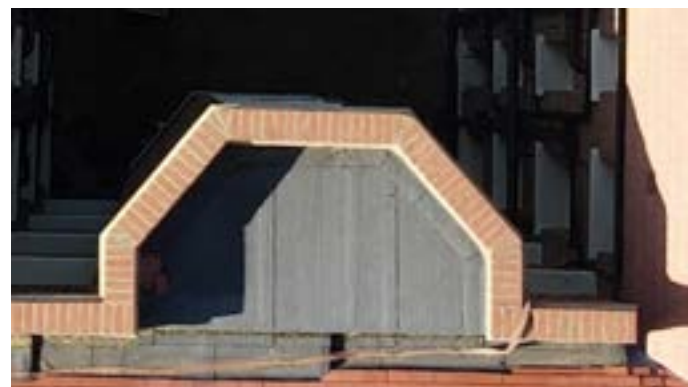
The small flat roof has been constructed with an overlapping felt system which appears to be in a good condition. The overlaps are in good condition with no sign of coming away. There is no staining or vegetation on the roof.

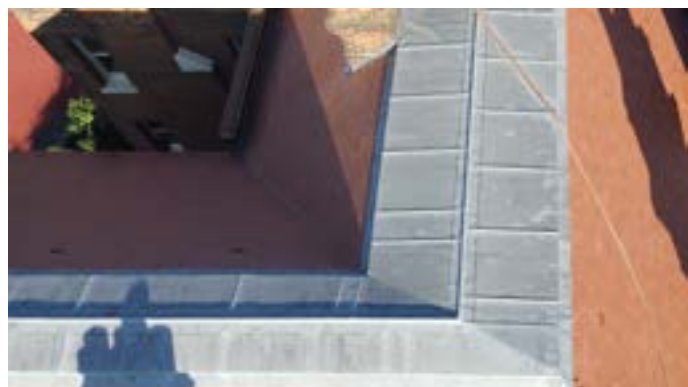
There is a metal ridge capping system. This appears to have been fitted fairly recently and is in an excellent condition.

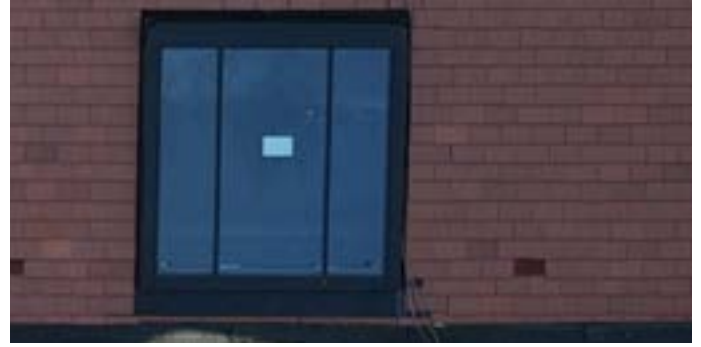
The roof light appears to be in good condition with no obvious problems with the flashing kit.

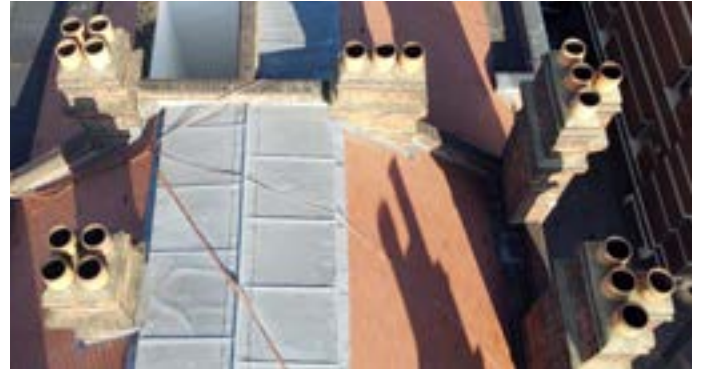
There are 20 chimneys in total on this block. The chimney stacks all appear to be in good condition. They are well rendered and the lead flashing appears to be fairly new, well fitted and watertight. One stack could do with repointing, and another could use rendering, but it is not a problem and can wait until scaffolding is on site for other work in the future

Overall, the roof is in good condition and does not require any immediate repairs. However, next time there is scaffolding on site it is recommended that some minor maintenance work be carried out to keep the roof in good condition for the long term. This work could include pointing some of the chimney stacks and re-flaunching any areas that are showing signs of wear and tear.

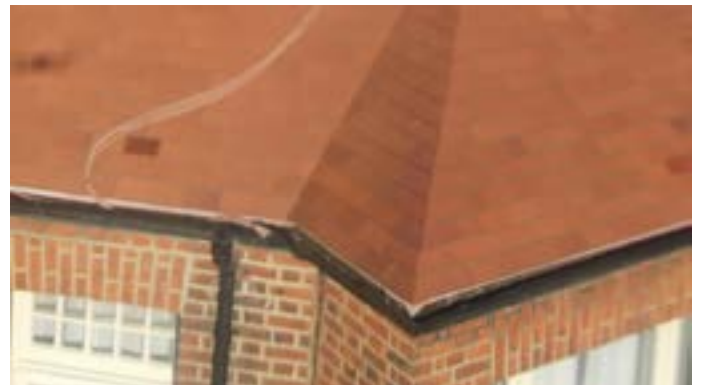
Most of the guttering is clear and the water flow is not impeded by any vegetation or debris, there are however a couple of sections which could do with cleaning out which are highlighted on the video along with the tile in the guttering.

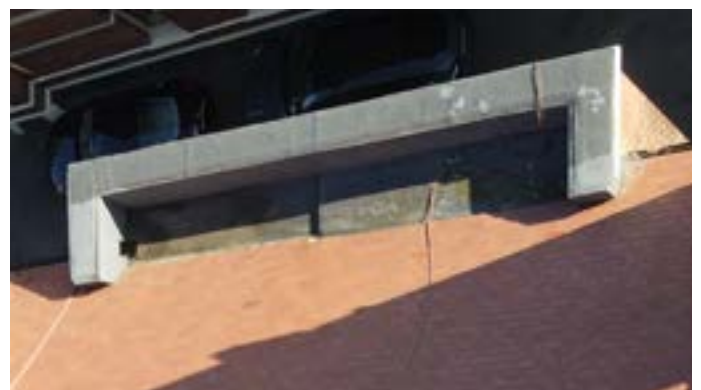
The bay has a sloped metal covering to allow rain water to flow through the outlet and into the adjoining guttering. It is all clear of vegetation and debris allowing the free flow of water
