A drone survey was carried out on 27 March 2025 at 10.00am to inspect the roof of

Roofing & Guttering Services

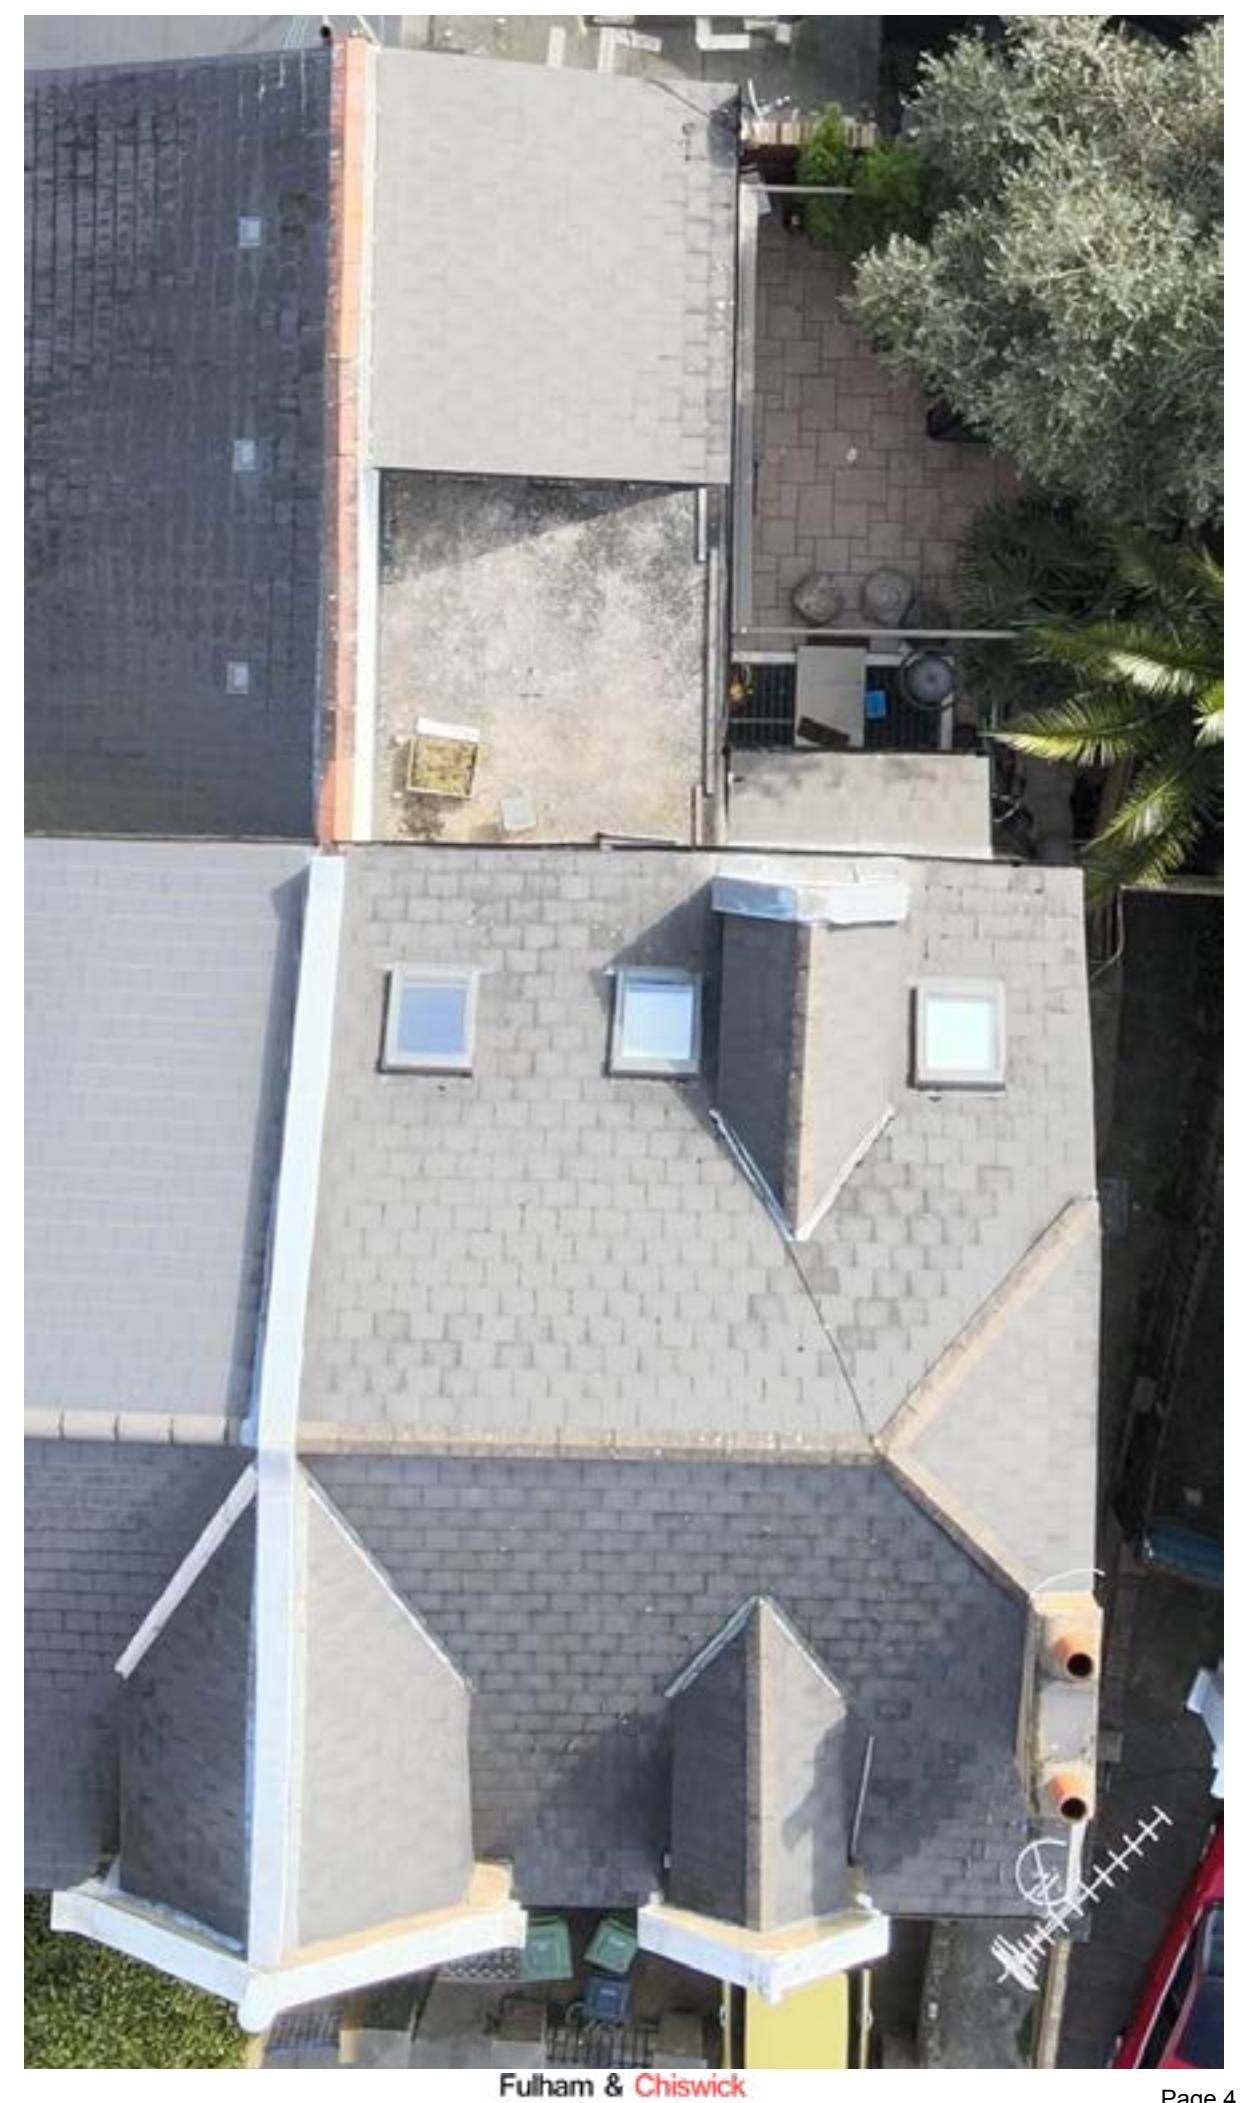
- Pitched roof with slate tile covering
- Flat roof section with what looks like asphalt covering
- Small pitched section with slate tile covering (following the flat roof)
- Smaller flat roof by the alleyway with felt covering
- · Two dormer windows with slate tile coverings
- Larger dormer at the front, shared with neighboring property, with slate tile covering
- Three skylights on the main roof
- Brick chimney with two clay pots
- Television antenna mounted on the chimney

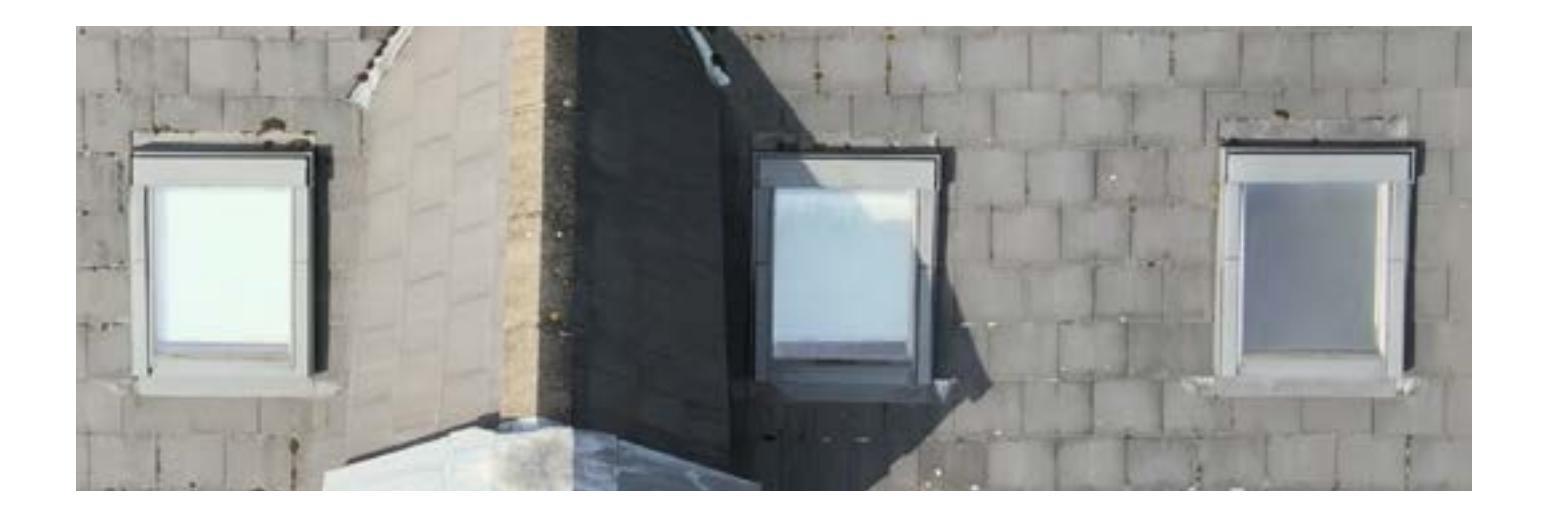
Roof Lights

- Three skylights are present on the main pitched roof
- The skylights appear intact with no visible cracks or damage to the glazing; the frames show minor weathering but remain structurally sound
- Associated flashing kits for the skylights all appear to be in place and watertight
- No reports of any internal water ingress related to the skylights

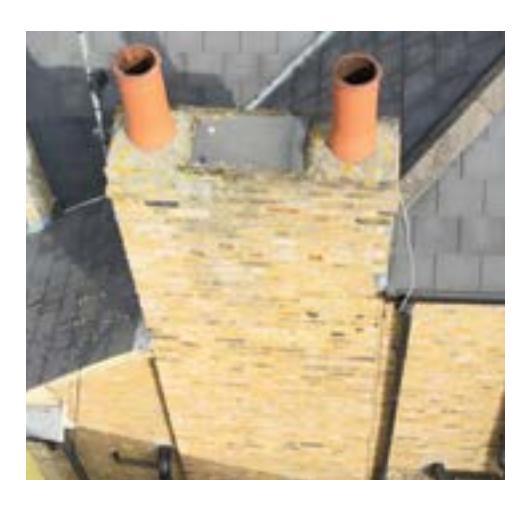
Chimney Stack

- One brick chimney is present on the right side of the main pitched roof •
- The chimney has two clay pots
- A television antenna is mounted on the chimney
- The chimney appears to be in good condition with no visible signs of structural damage or deterioration
- Lead flashings are all in place and appear watertight •
- The top of the chimney has had recent repair work, with a smoother layer of mortar or cement • visible around the base of the chimney pots
