Roofing & Guttering Services

Drone Survey Report

Property	Phoenix Lodge Mansions Brook Green London W6 7BG
Date	10 August 2023
Client	Katie Steward
Purpose	Client requested a roof report
Prepared By	Steve Scannell 07738 359841

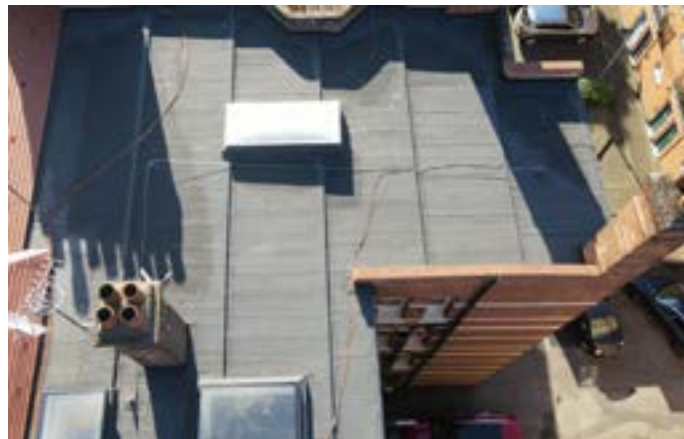
Block A Roof Covering (continued)

Ridge/Capping

There is a metal ridge capping system. This appears to have been fitted fairly recently and is in an excellent condition.

There is also a section of roof with a concrete / clay ridge system in place which looks fairly new and is in an excellent condition
