A drone survey was carried out on 27 March 2025 at 10.00am to inspect the roof of

Roofing & Guttering Services

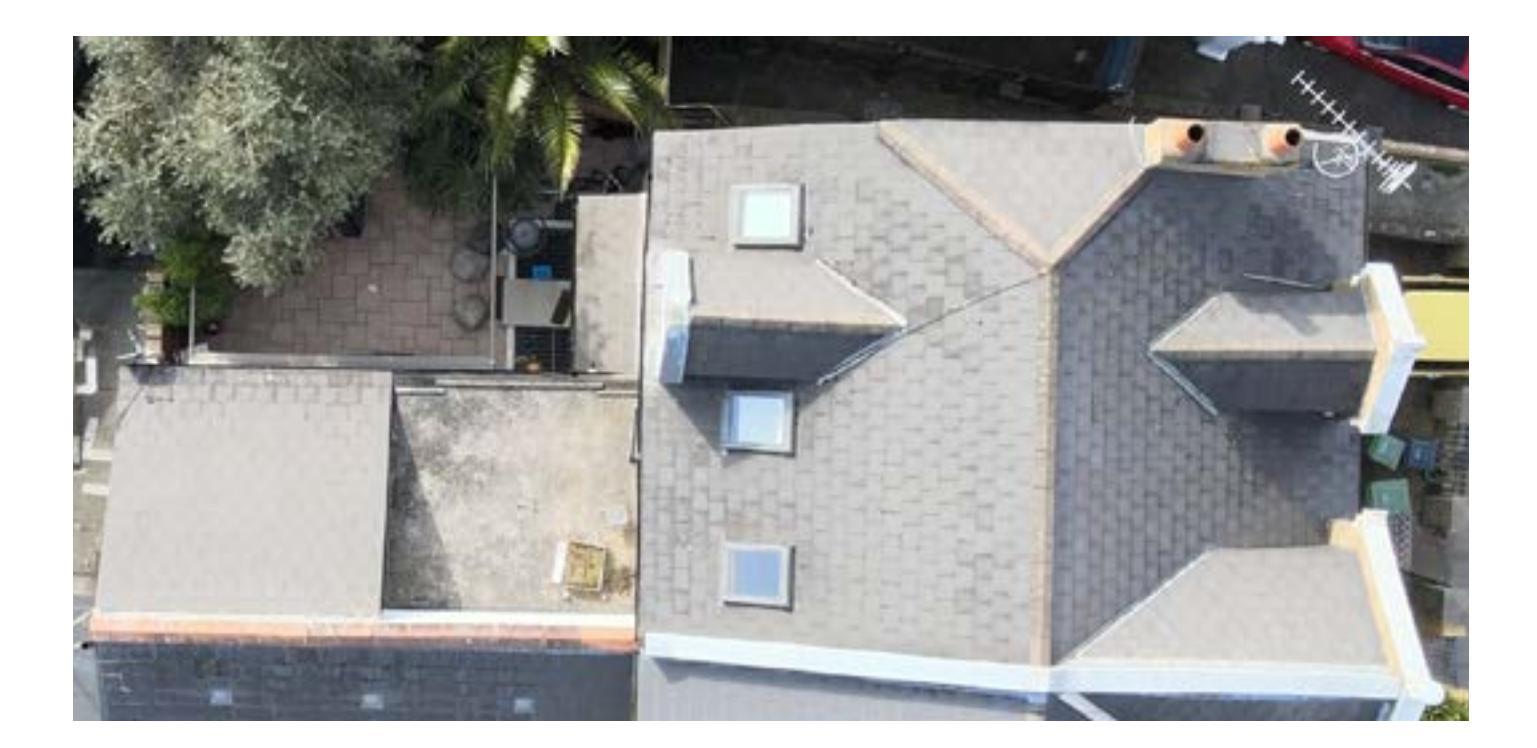
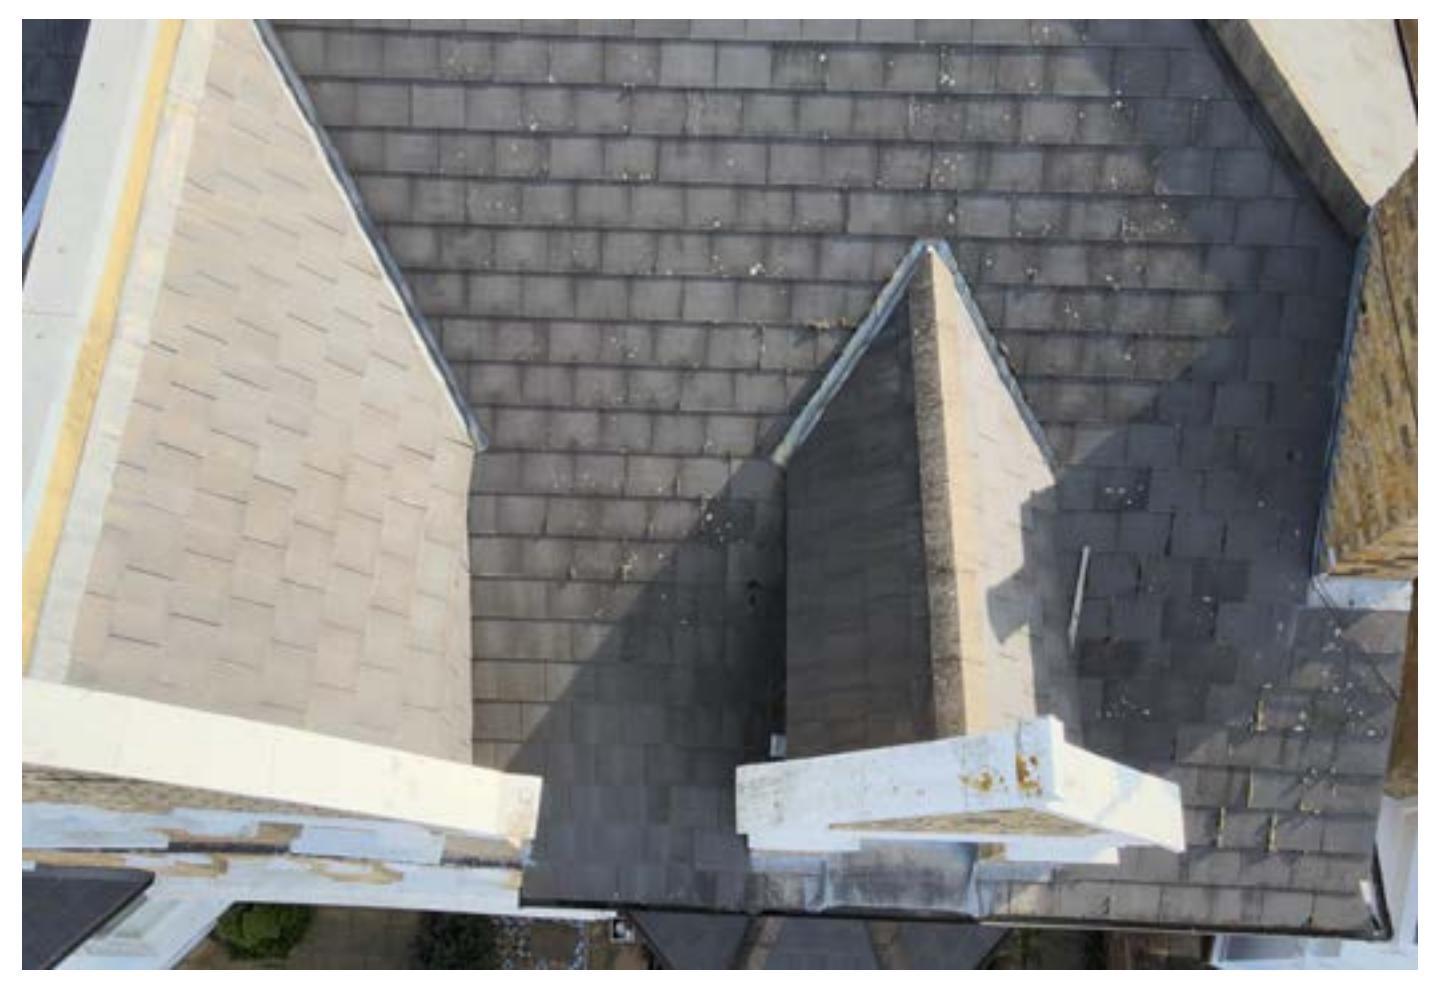
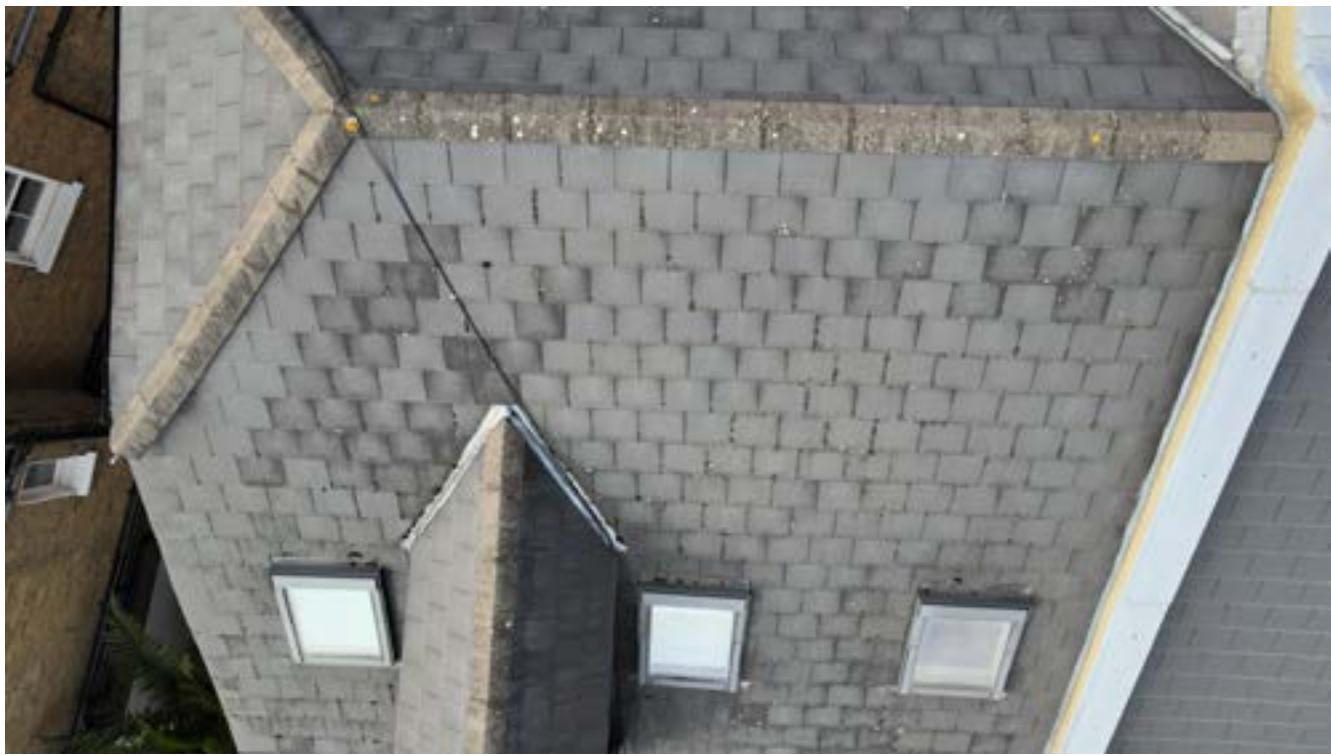
Roof Lights

- Three skylights are present on the main pitched roof
- The skylights appear intact with no visible cracks or damage to the glazing; the frames show minor weathering but remain structurally sound
- Associated flashing kits for the skylights all appear to be in place and watertight
- No reports of any internal water ingress related to the skylights
